# Four Point Insurance Report

123 Main St.  
Anytown, FL 32756

### Note **Four Point Insurance Inspection Report**

Date of Inspection March 20th 2008

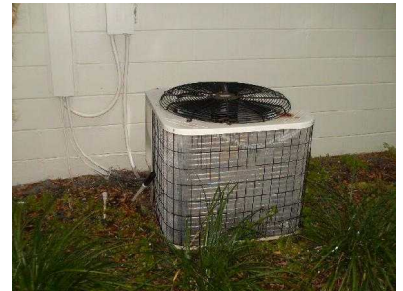
Right side of home; AC System

3. Heating system upgraded, year: 2002
4. Fuel tank located: N/A
5. Condition of heating system: Good
6. Heating system comments: HEATING SYSTEM COMMENTS; Functioned correctly at the time of the inspection:
7. Types of cooling system: Central air;
8. Estimated age of cooling system: 2002
9. Cooling system upgraded: 2002
10. Condition of cooling system: Good
11. Cooling system comments: COOLING SYSTEM COMMENTS; Functioned correctly at the time of the inspection:

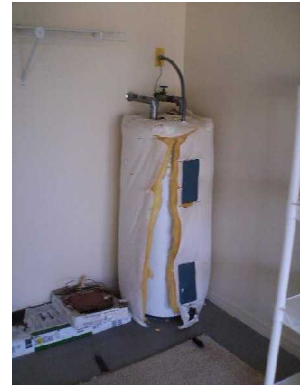
10. Approximate age of water heater; 2002
11. TPR valve present? Yes
12. Fire sprinkler system present? No
13. Freeze hazards noticed? No
14. Polybutylene noticed? No
15. Plumbing leaks noticed? No
16. Recent plumbing upgrades? Year? 2002
17. Overall plumbing condition; Good
18. Plumbing comments; The water pressure remained constant when various faucets were operated simultaneously

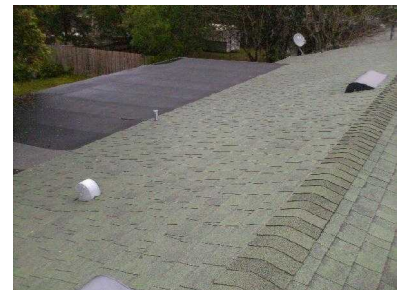
3. Estimated age of roof covering; 3 to 5 years
4. Number of shingle layers; One

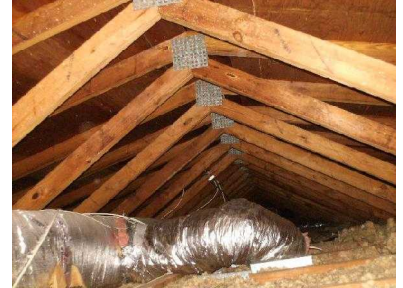
- 6. Flashing damage noticed; None
- 7. Missing shingles or covering; No
- 8. Truss or rafter damage noticed; No
- 9. Evidence of active leaks; No
- 10. Estimated life expectancy; 15 to 18 years
- 11. Roof comments; The roof covering is in good condition.

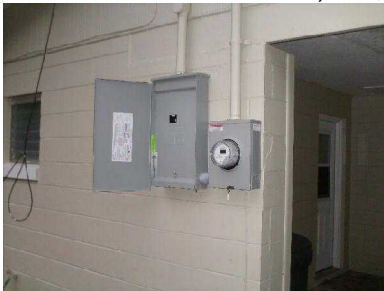
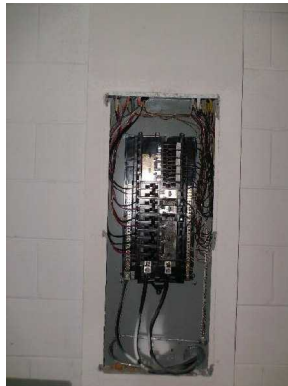
- 3. Main panel location; Left side, exterior;
- 4. Panel ground observed? Yes;
- 5. GFCI's present where required? Yes
- 6. AFCI's present in bedrooms; N/A
- 7. Aluminum branch circuits? No
- 8. Active Knob and tube wiring; No
- 9. Exposed or unsafe wiring noticed; No
- 10. Recent upgrades? year? 2008
- 11. Overall electrical system condition; Good
- 12. Electrical comments; The system is in good condition the panels were opened and inspected. no faults were noted.
