Home Mold Inspection Report

12121 Terragona Drive
Mount Dora, Fl 32757

Prepared for: A N Other

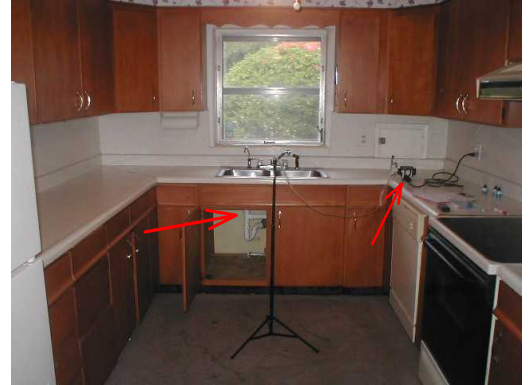
Two Between master bedroom and master bathroom
Three Kitchen

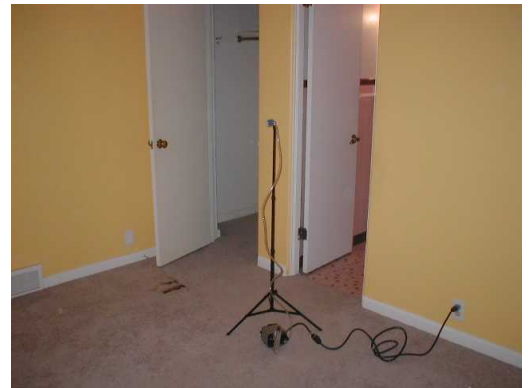
Four East bedroom / bathroom. Pump set up between the two rooms.
Five Center bedroom / bathroom. Pump set up between the two rooms
